# **Assessment of Dam Safety of Coal Combustion Surface Impoundments**

**Indianapolis Power & Light Company**

**Eagle Valley Generating Station**

**November 15, 2010**

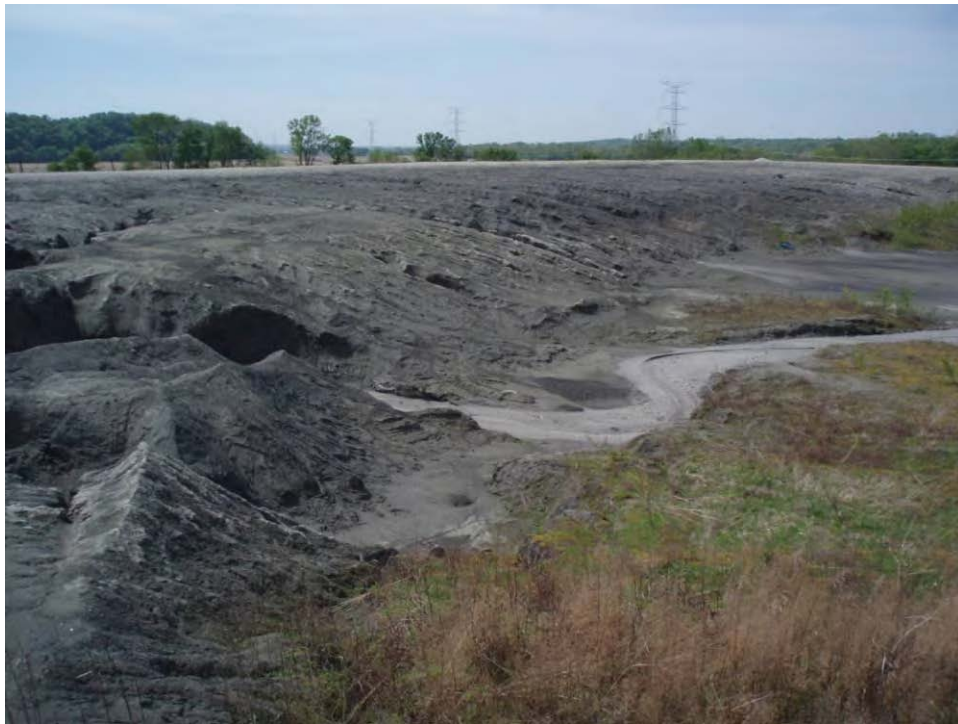
128. Pond D - Limit of ash at end of divider embankment prior to failure, looking southwest.

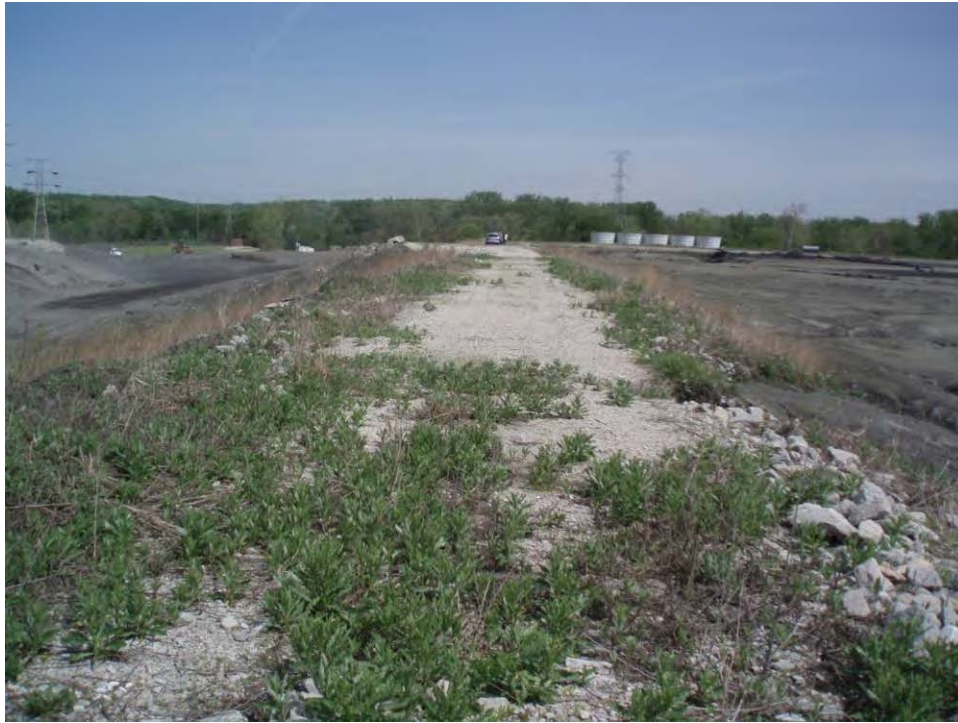
129. Pond D – Crest of divider embankment, looking north.

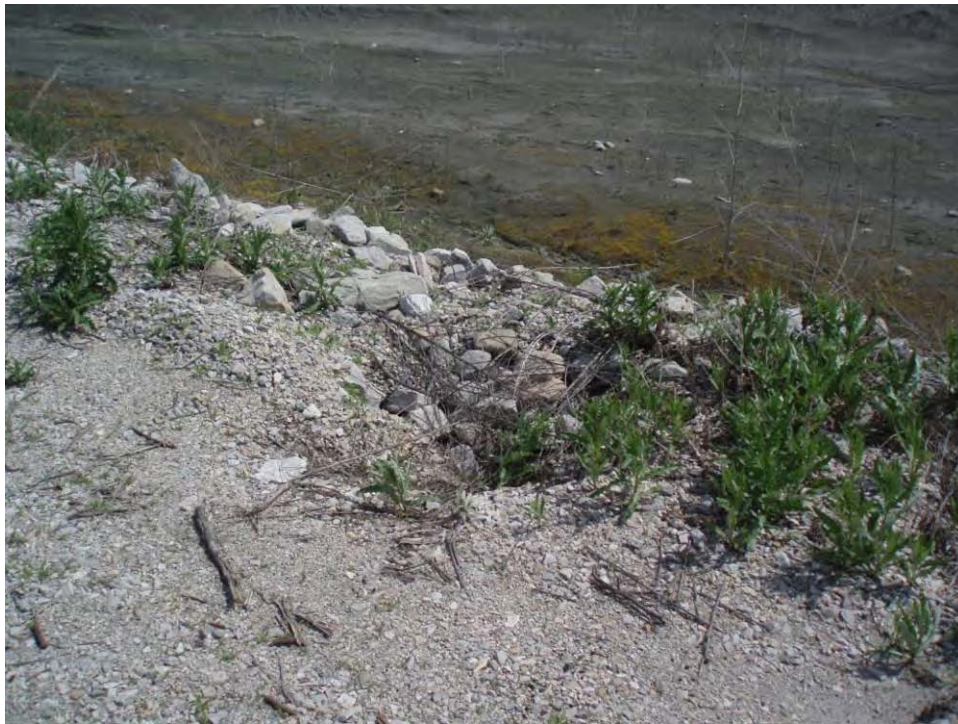
130. Pond D – Depression with piping on east slope of divider embankment, looking northeast.

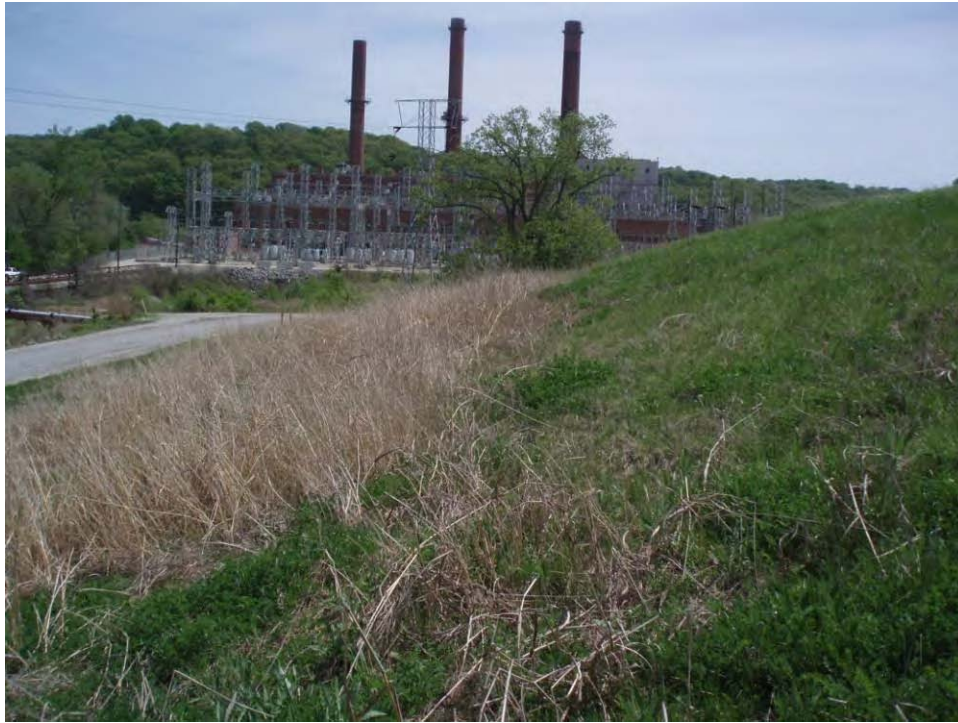
131. Pond D - North embankment exterior slope, looking east.

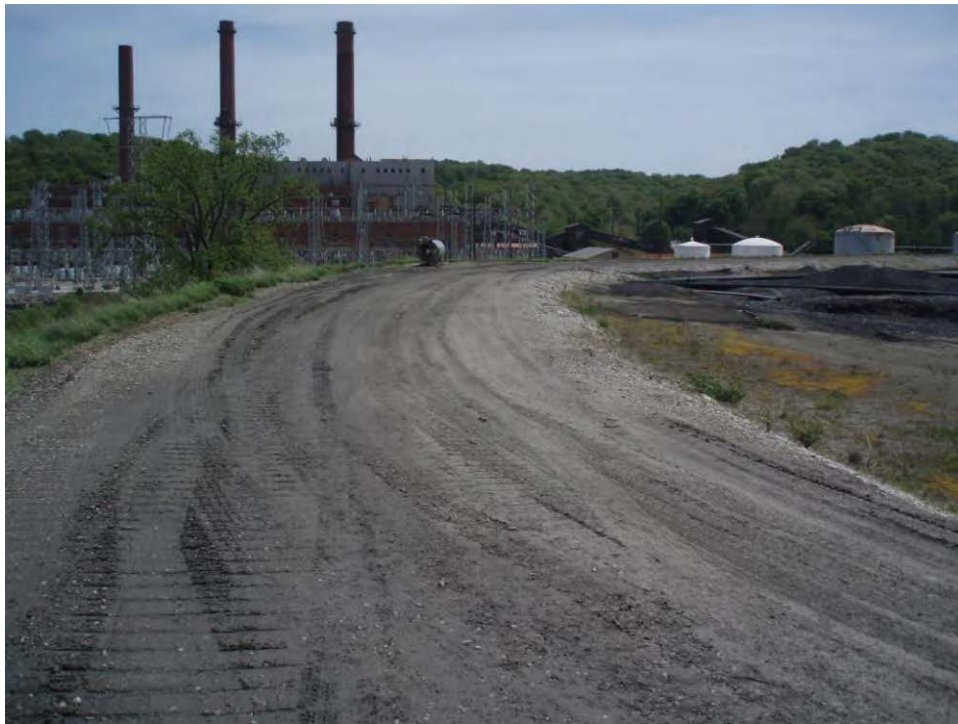
132. Pond D - North embankment crest, looking east.

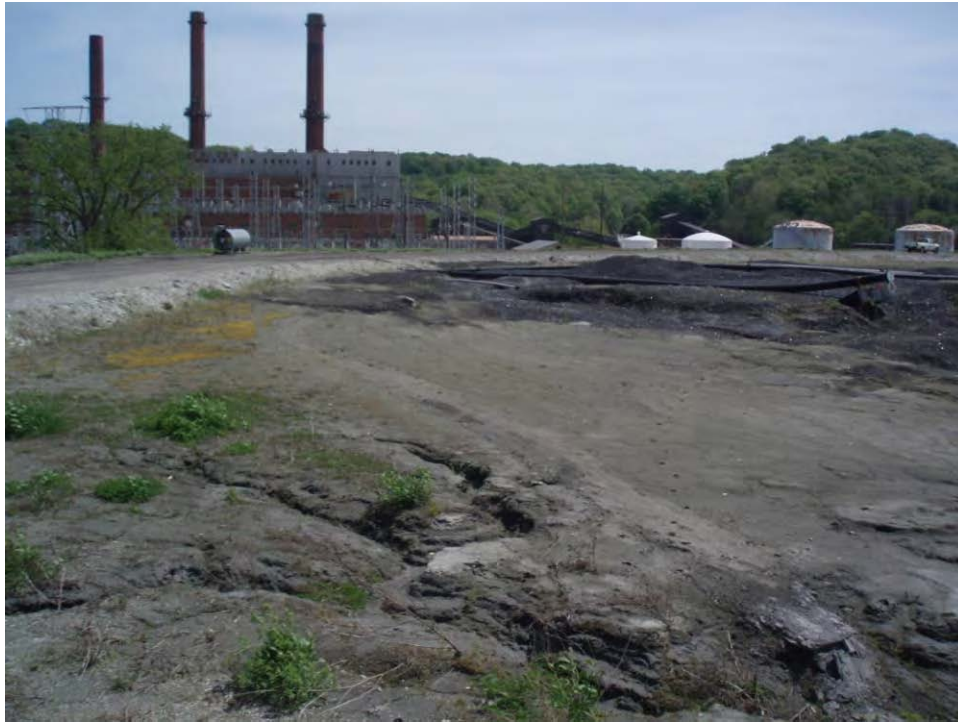
133. Pond D - North embankment interior slope, looking east.

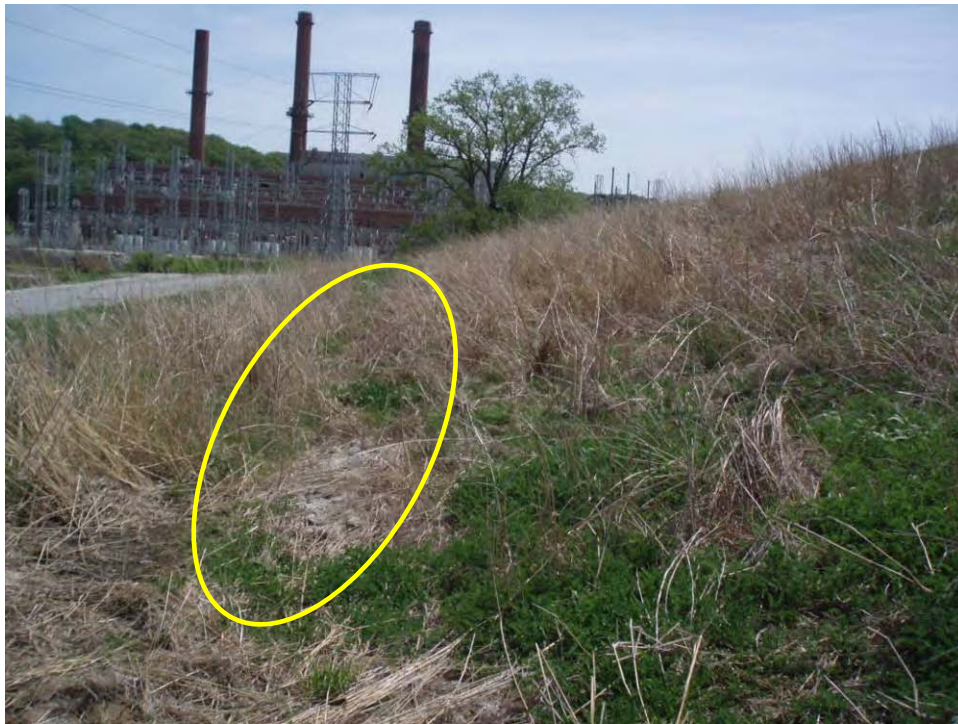
134. Pond D - Toe of north embankment, looking east. Note drainage ditch with seepage collector pipe.

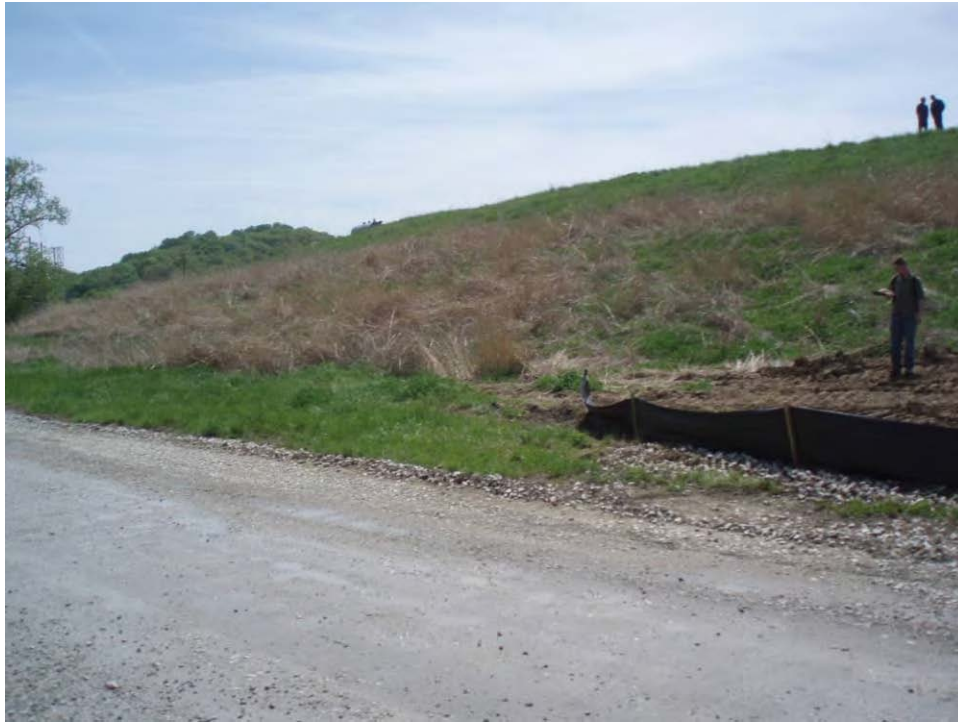
135. Pond D – North embankment exterior slope, looking southeast.

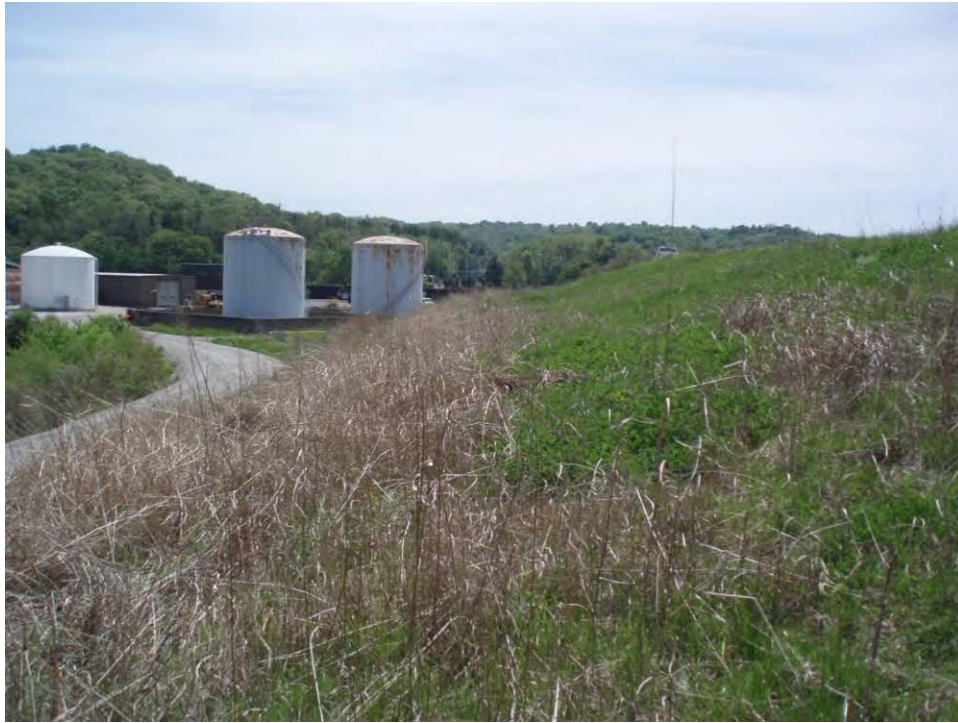
137. Pond D – Northeast embankment exterior slope, looking southeast.

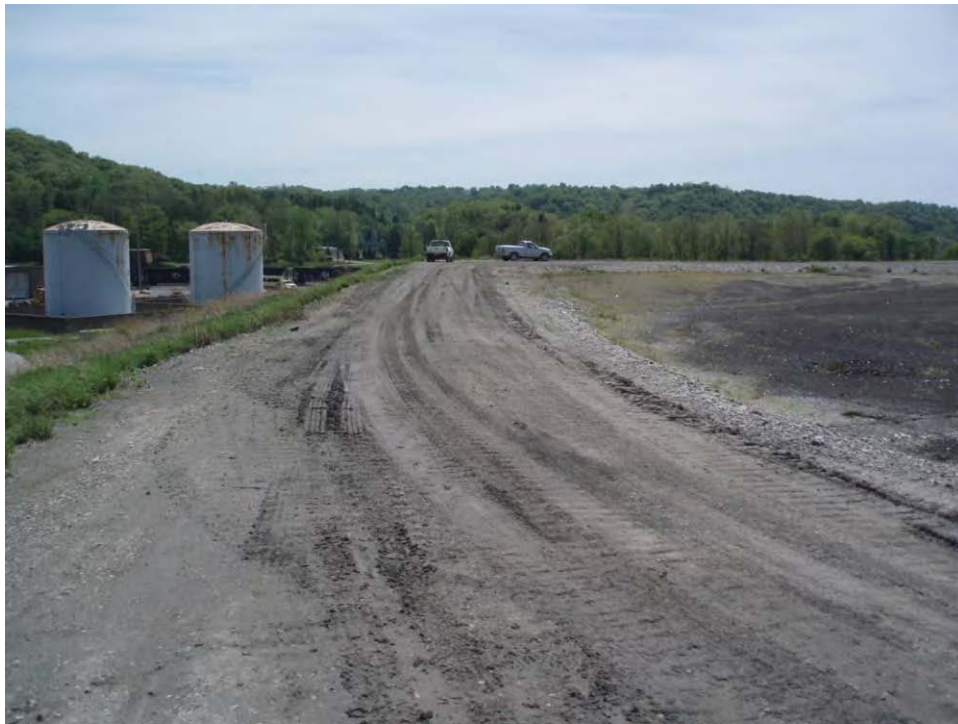
138. Pond D – Northeast embankment crest, looking southeast.

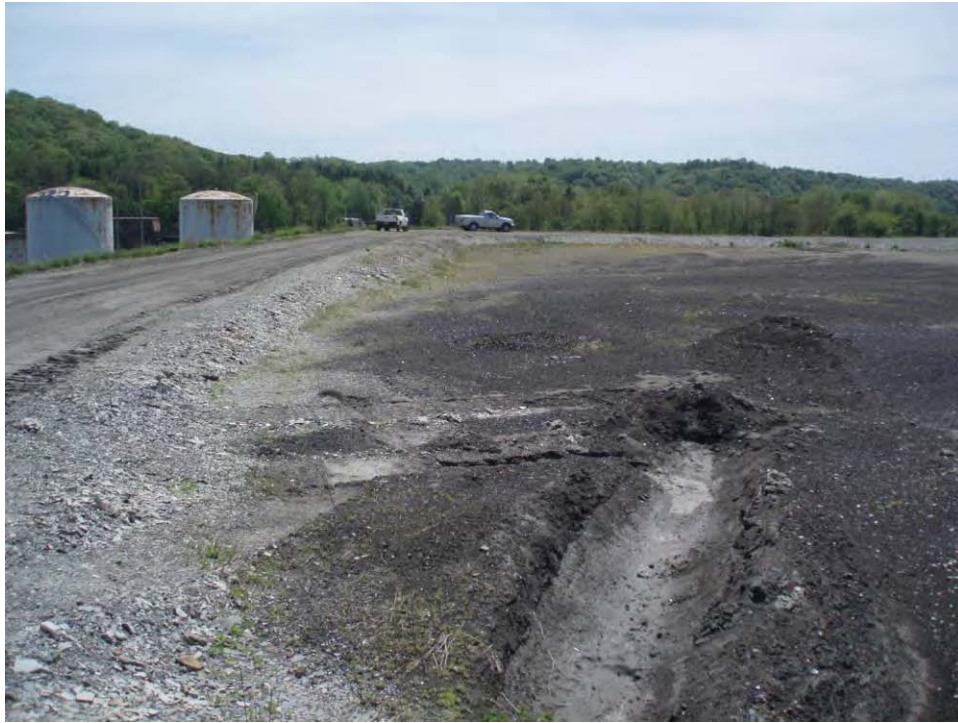
139. Pond D – Northeast embankment interior slope, looking southeast.

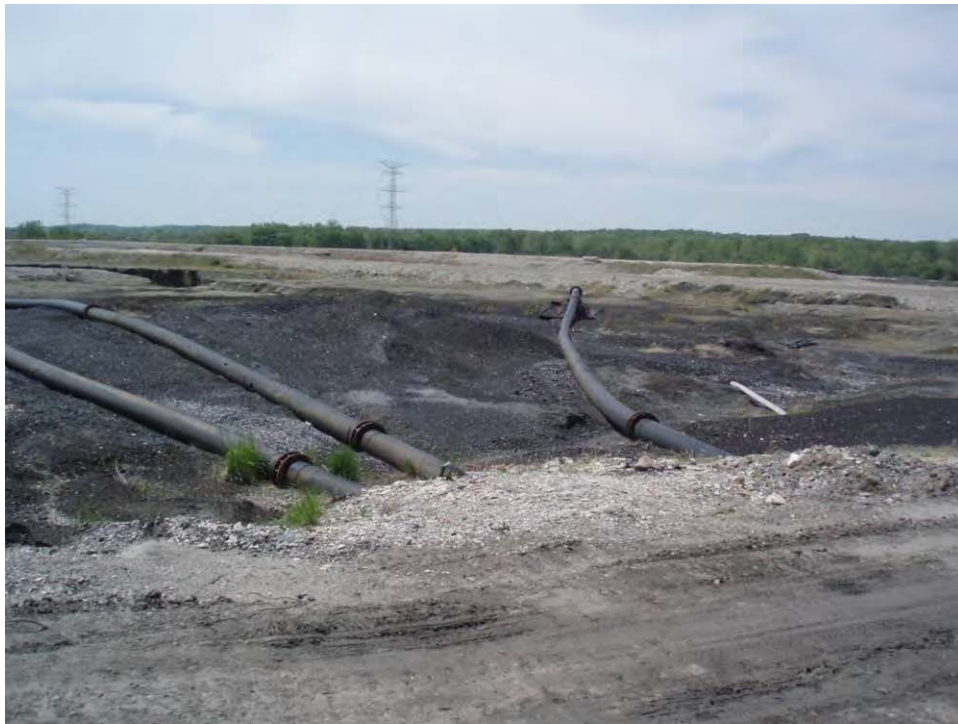
140. Overview of three 10-inch-diameter HDPE discharge pipes into Pond D, looking southwest.

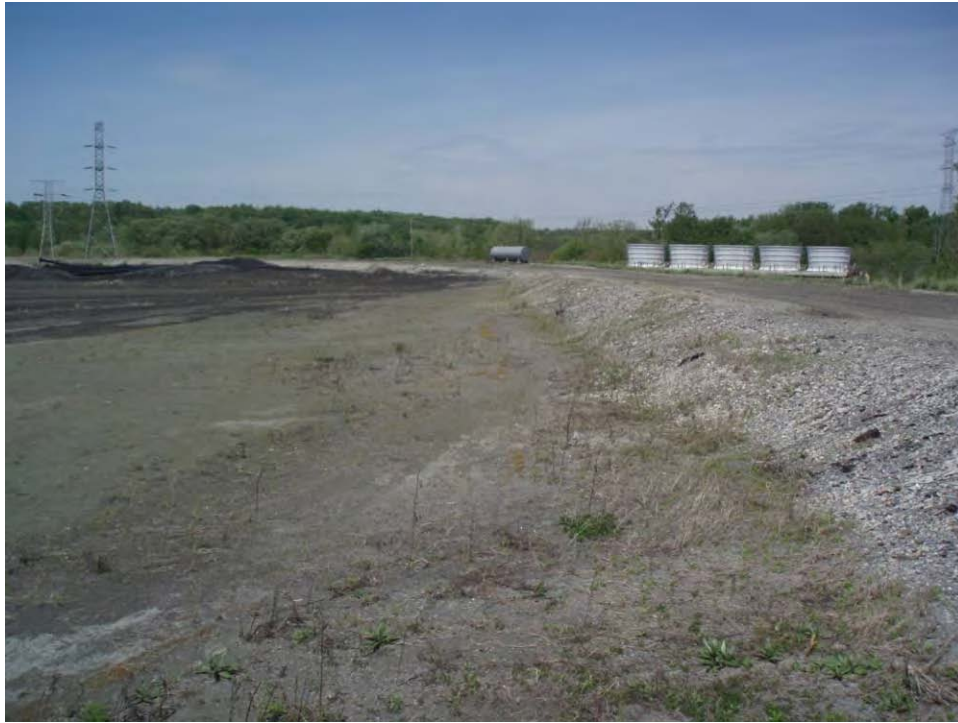
141. Pond D - Northeast embankment interior slope, looking northwest.

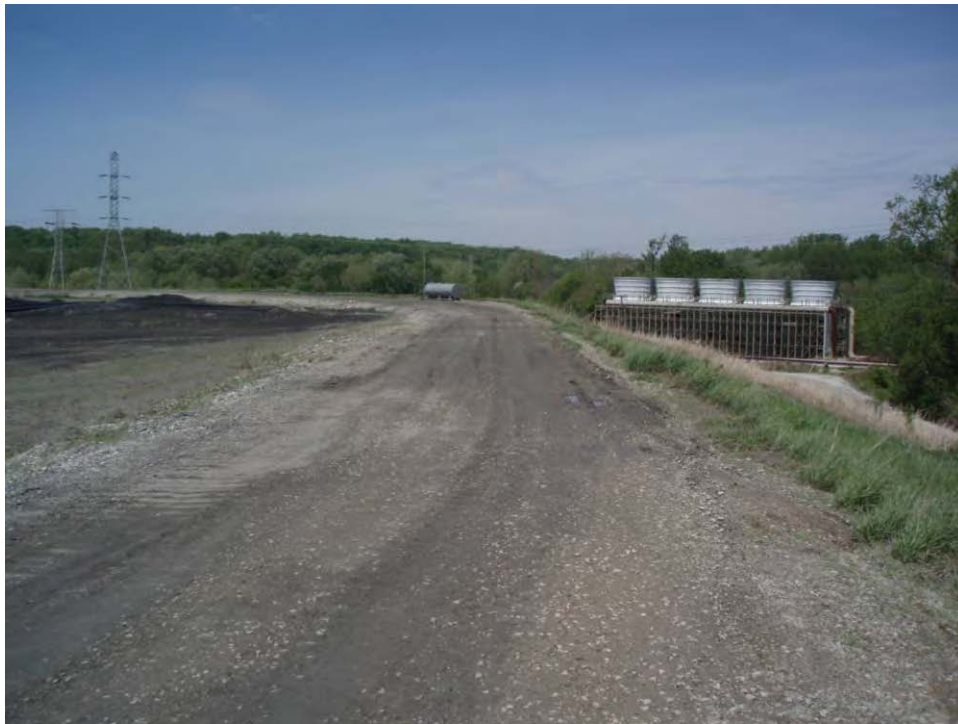
142. Pond D - Northeast embankment crest, looking northwest.

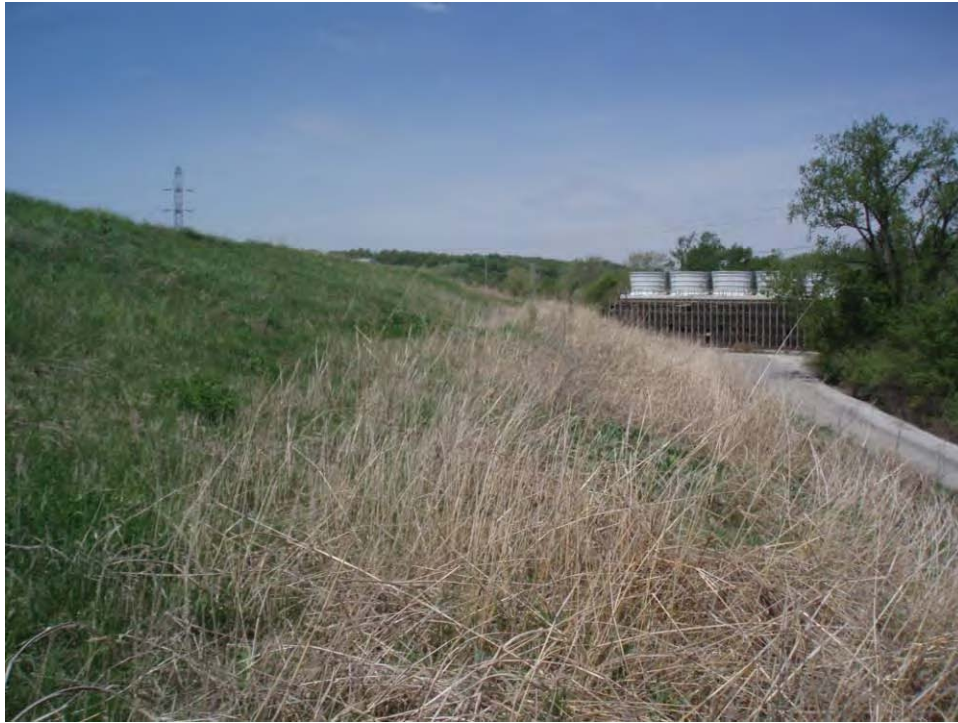
143. Pond D - Northeast embankment exterior slope, looking northwest.

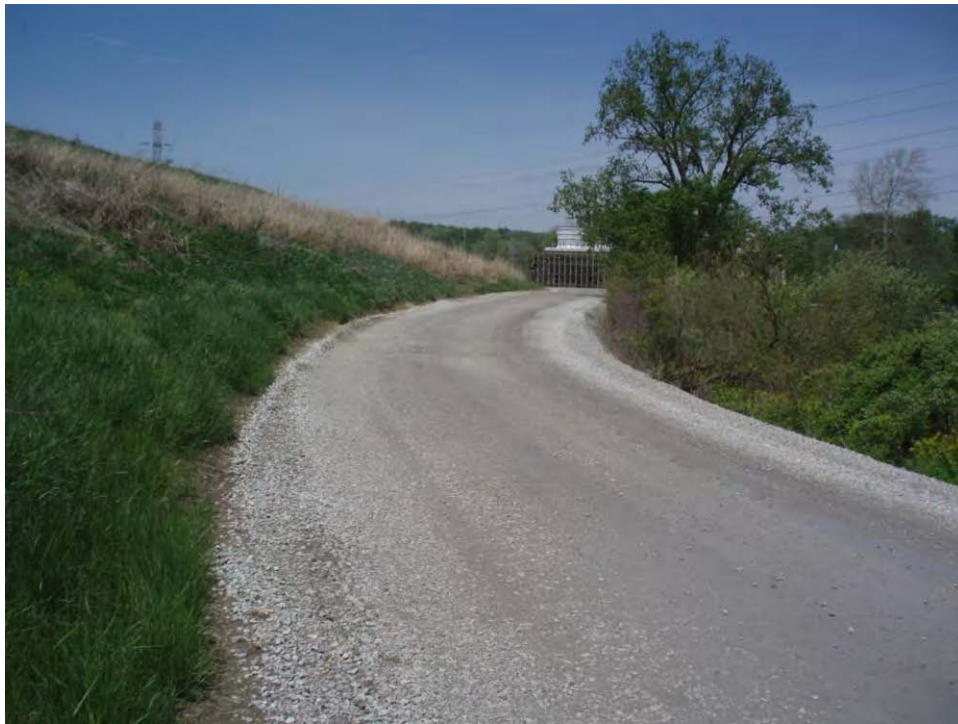
144. Access road and discharge canal adjacent to toe of Pond D, looking northwest.

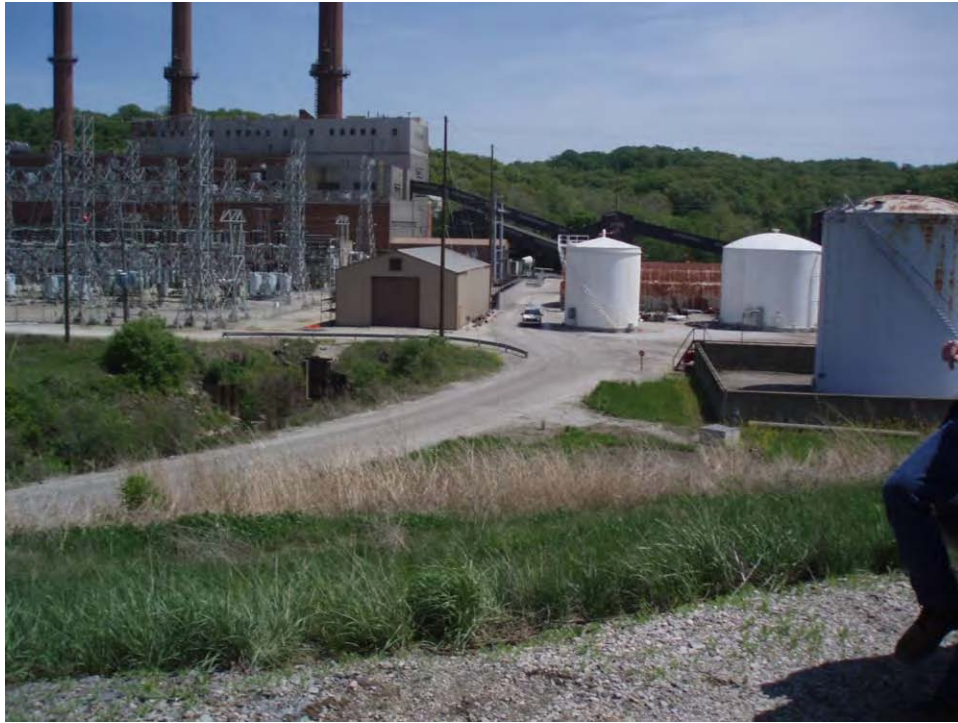
145. Downstream area of Pond D northeast embankment, looking east.

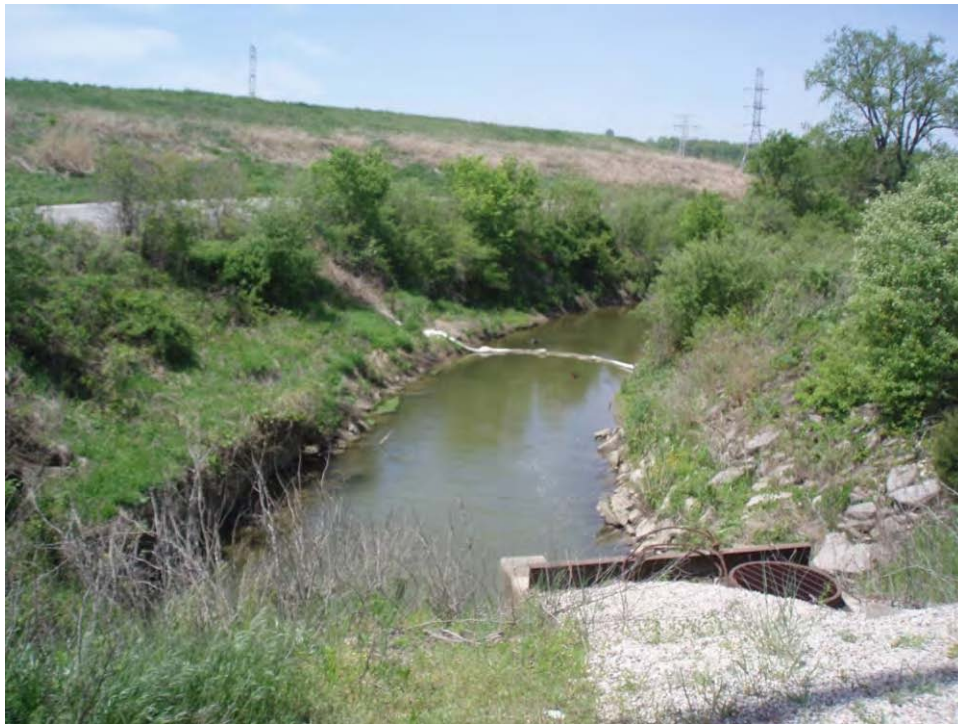
146. Overview of typical discharge canal adjacent the north embankments of Ponds A, C, D, and E.
